7'10 1 - 8 December 1, 1983 DATE: Final Site Report - Riss International SUBJECT: Superfund Site Number: Jl Michael D. Erbaugh FROM: Region VII TAT - Team Leader John C. Wicklund TO: Director, ENSV William J. Keffer THRU: Chief, EP&R/ENSV NAME OF SITE: Riss International 3635 Chouteau St. Louis, Missouri SITE CONTACT: Loretta Dunovich Kansas City, Missouri Office 1-800-892-5795 SITE LOCATION: The site is located approximately 1/2 block west of Grand Blvd. on Chouteau in St. Louis, Missouri. This site is located in an industrial section within the City limits of St. Louis, Missouri. Pevely Dairy is located south of the site on the opposite side of Chouteau. Another truck terminal is located west of this site and a scrap metal facility is located directly to the east. There are no residences in the vicinity. SITE HISTORY: The site was identified by a former driver for Russell Bliss as having been sprayed by the Bliss Company during the period of interest. Strickland Truck Lines occupied this site in the early 1970's, after which time the site was vacant for several years before Riss purchased it in 1978. Leaseway Express and Arkansas Freightways have been leasing sections of this sit

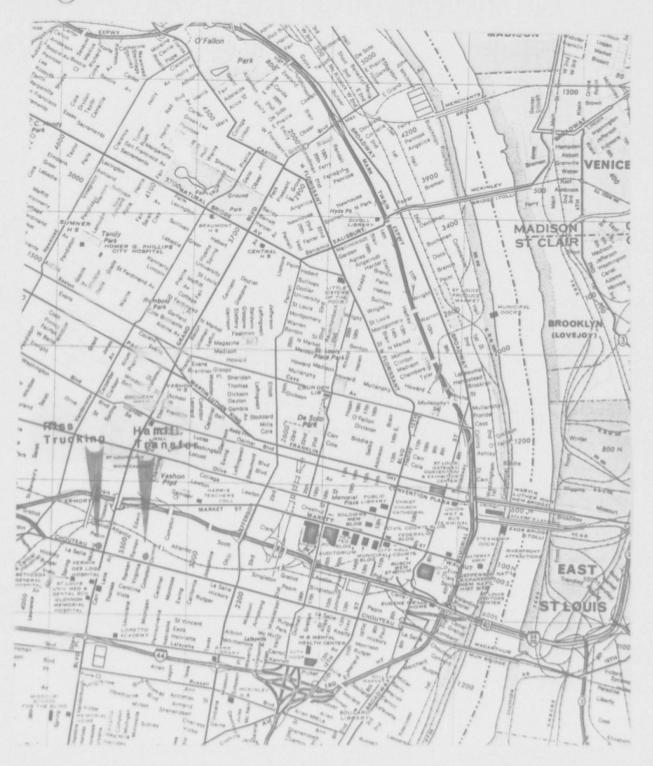
Locations of Hamill Transfer and Riss Trucking. 1 inch = 0.71 mile.

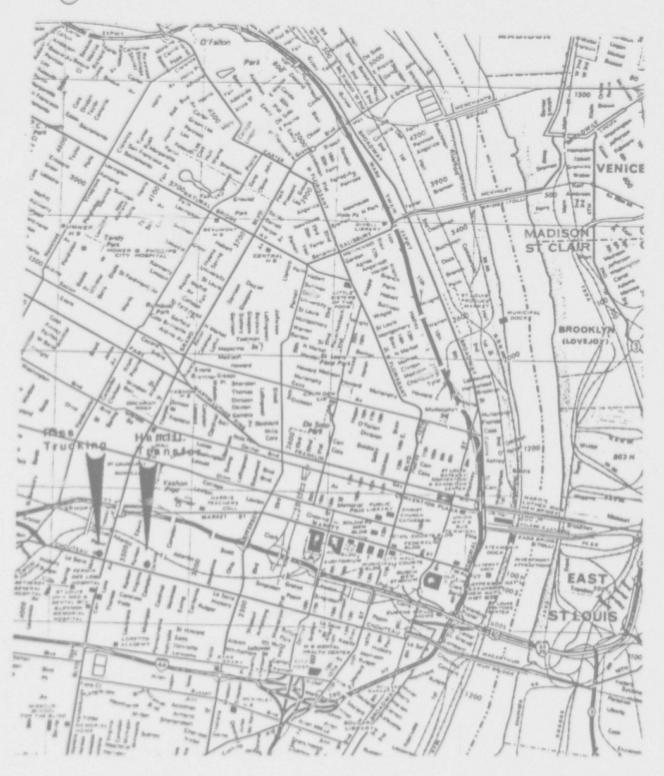
Locations of Hamill Transfer and Riss Trucking. 1 inch = 0.71 mile.
